## Recoating a Natural Gas Tank at Sunny Solar Turbine Plant

Replace the failing coatings of an exterior system on a natural gas tank in a Class I, Division 1 no-spark area

60' long by 12' wide 30,000-gallon fuel tank

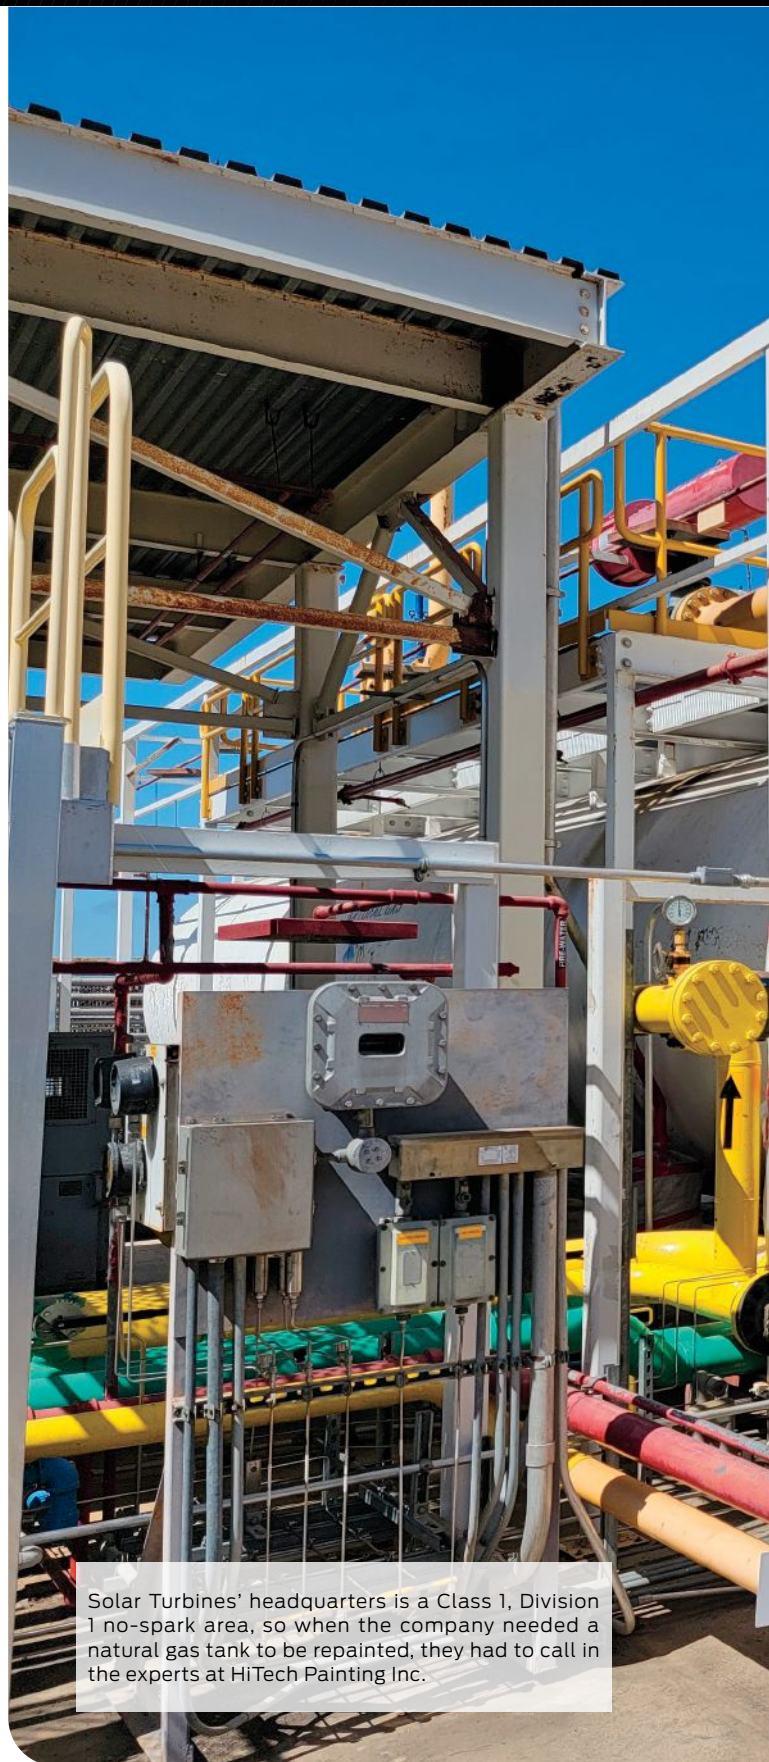
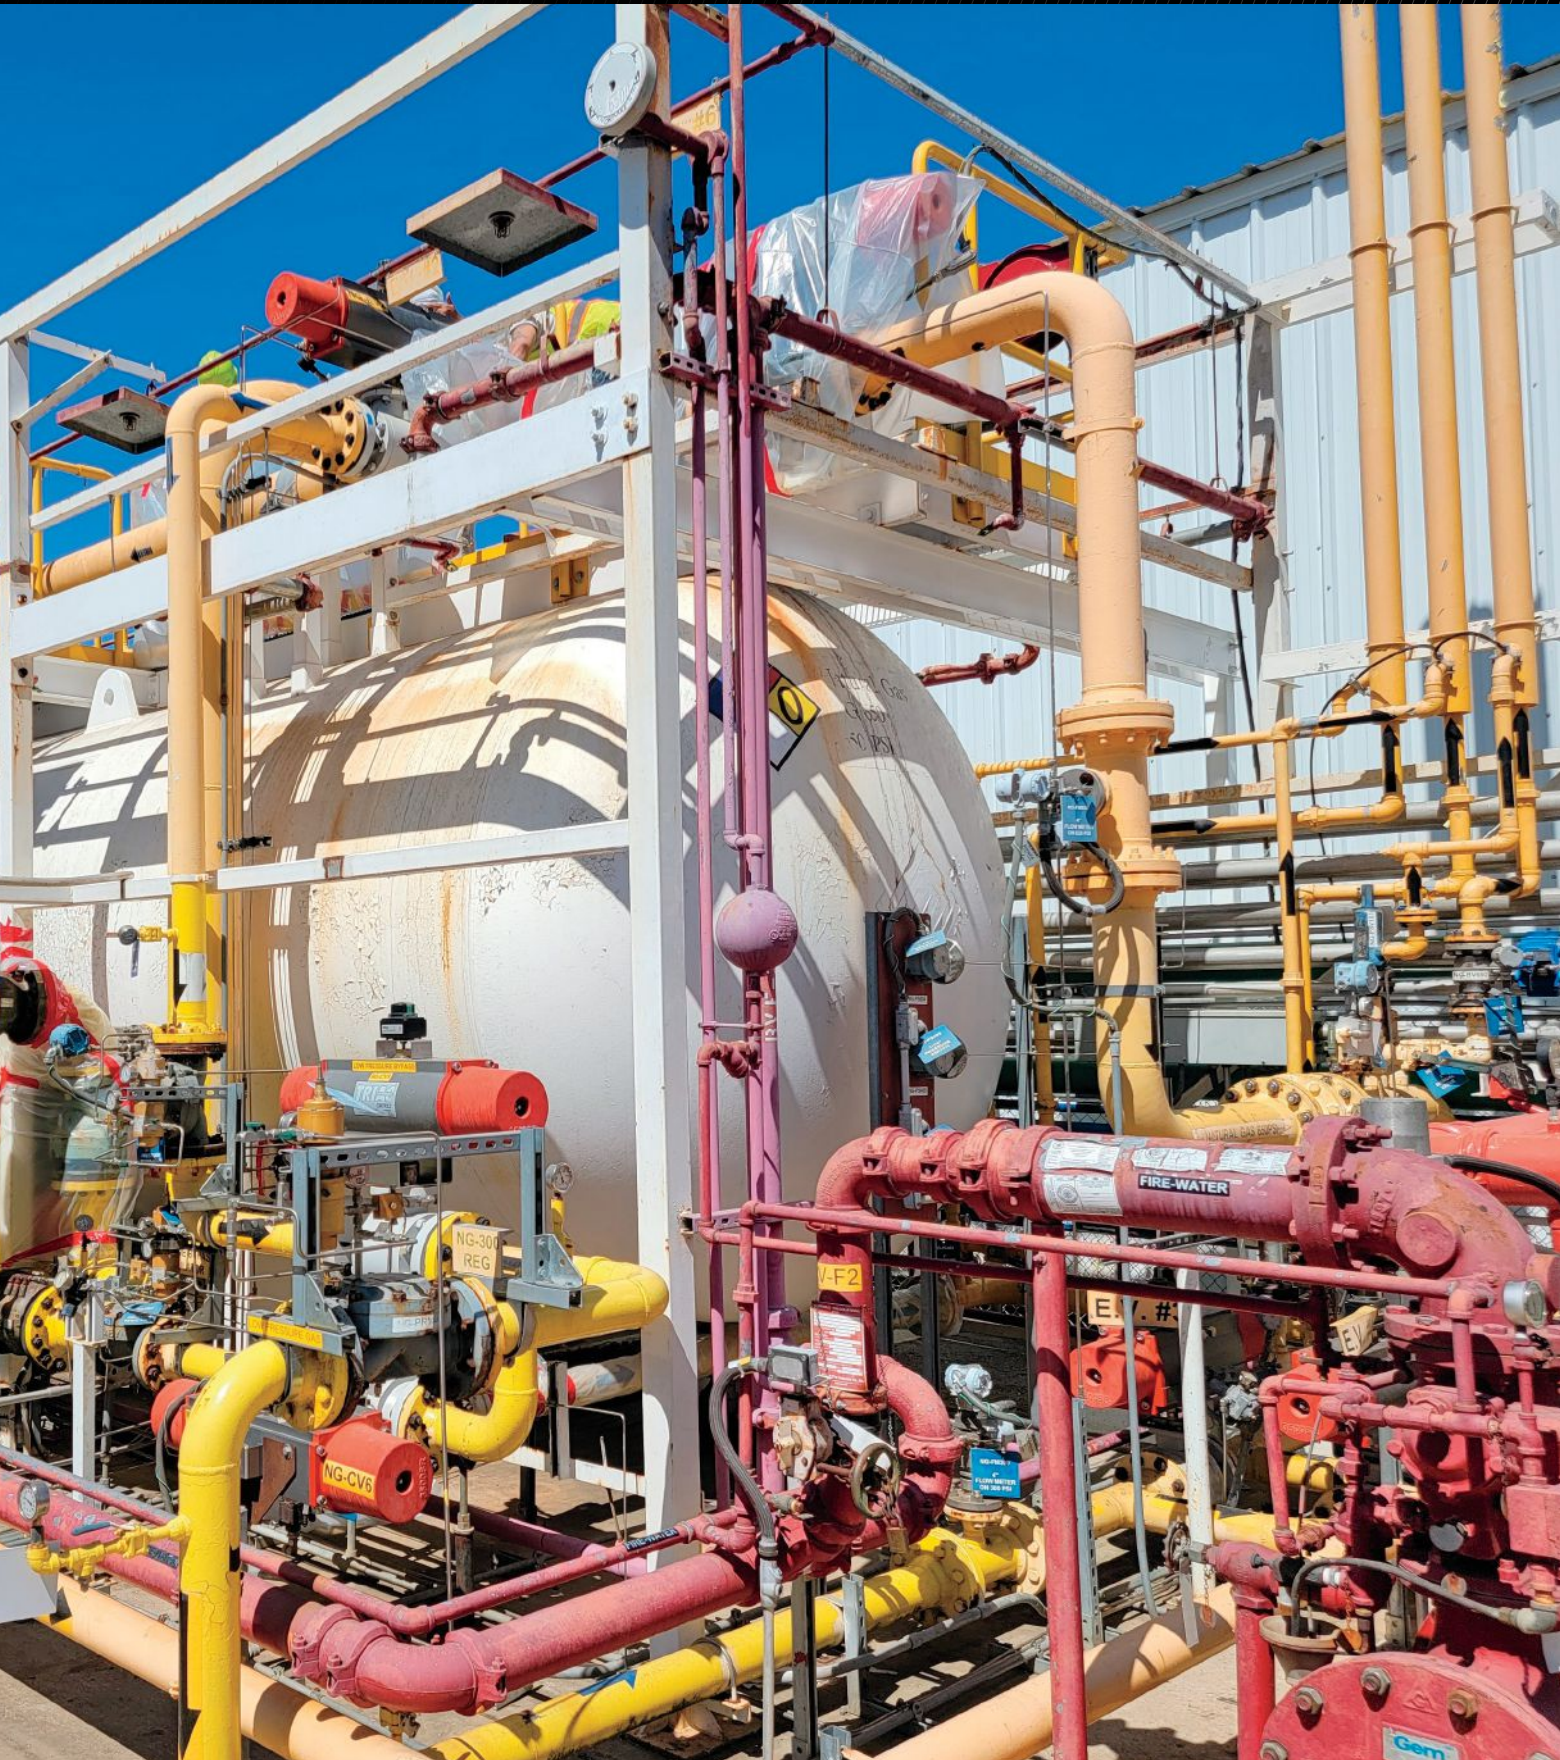
Solar Turbines' headquarters is a Class 1, Division 1 no-spark area, so when the company needed a natural gas tank to be repainted, they had to call in the experts at HiTech Painting Inc.

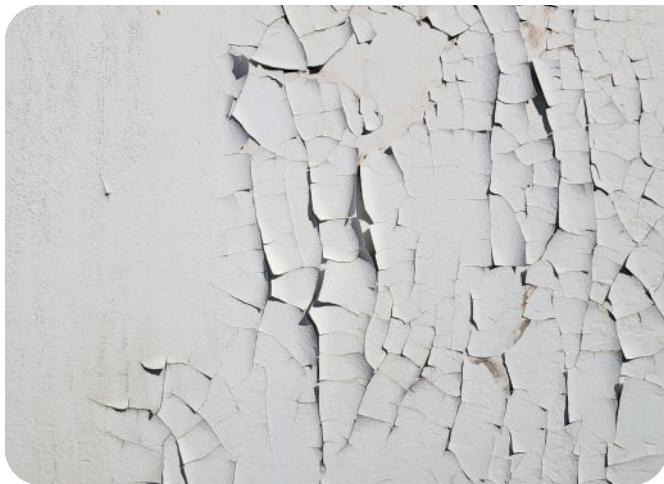
The coatings on the 60-foot long by 12-foot wide 30,000-gallon fuel tank were failing. Over three weeks, the crew would recoat the prepped steel with a Sherwin-Williams system.

The coatings application portion was fairly straightforward. For the 30,000-gallon (113,562.4 L) live natural gas fuel tank, the crew applied a total overall average dry film thickness of 10.9 mils (276.9 microns). They put down Sherwin-Williams’ Pro-Line 4000 Two Component High Build Epoxy Barrier Coat in one coat and Pro-Line Hi-Solids Polyurethane 250 two-component, aliphatic, acrylic polyurethane resin coating in two coats.

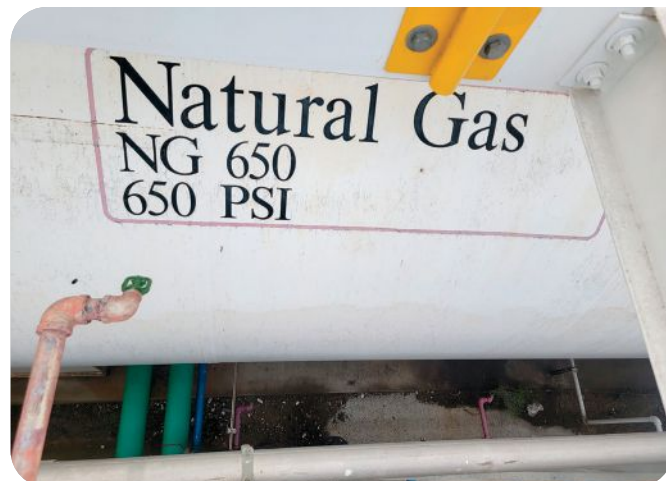
Because the tank was still in service during this project, the crew used vapor-blasting specs from the Navy and had to work within a 7-mile blast radius.

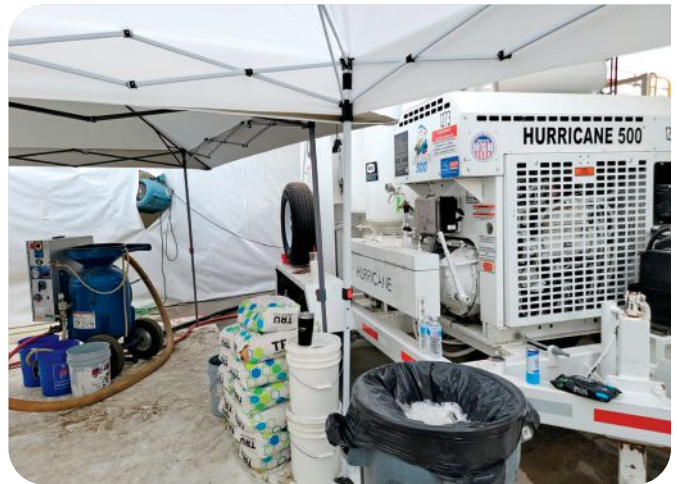
The six-person crew from HiTech used crushed glass and a vapor blaster to prepare the steel surface. They achieved a profile that adhered to the SSPC-SP-6 standard.

"After we removed all of the failing coatings, we did an SP-6 commercial blast," Heuslein said. That's SSPC: The Society for Protective Coatings/NACE No. 3 Surface Preparation 6, "Commercial Blast Cleaning." They completed that with Graco's

EcoQuip 2 Mobile, CHLOR\*RID's HOLD\*BLAST to remove the chlorides, and the glass media from TruAbrasives. According to Heuslein, the EcoQuip uses so little media compared to dry blasting that the crew was able to manage any spent media by hand. "So 33% of your allowed stains are intact coatings. And so I got all that. I did my inspections and got it all ready. And then we sprayed on an epoxy primer and brush and rolled in the hard-to-get areas. And then we sprayed on the polyurethane

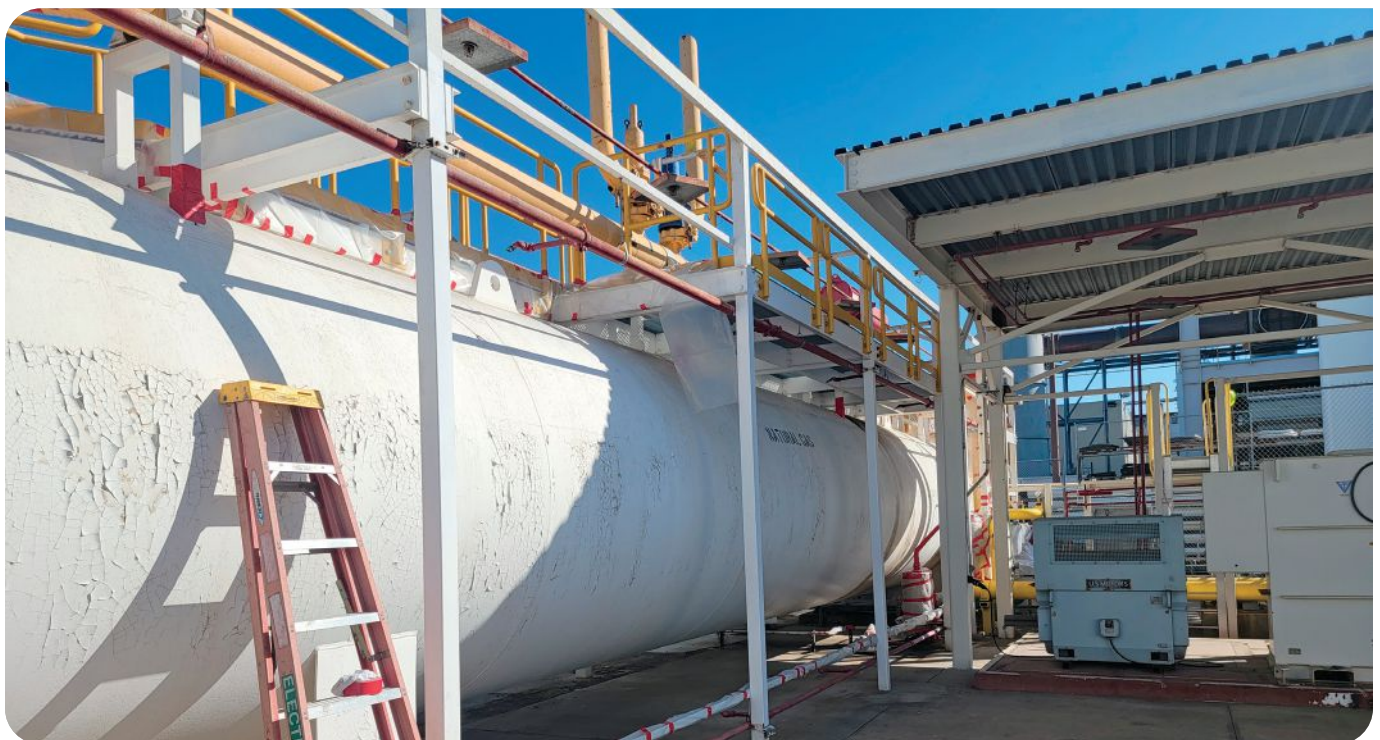
Access also had to include consideration for the no-spark zone. The crew was sure to equipment without steel, including hammers and scaffolding.

"You can't use a [steel] hammer — you have to use a brass hammer for the spikes — for the scaffolding for no sparks," Heuslein said. "You can't have a spark, so I figured out we could put up scaffolding and put up a barrier around it and then vapor blast it with recycled glass. Recycled glass is not going to leave a spark on a metal tank. I wrote the specs on this, and submitted it to the engineers." And they approved.

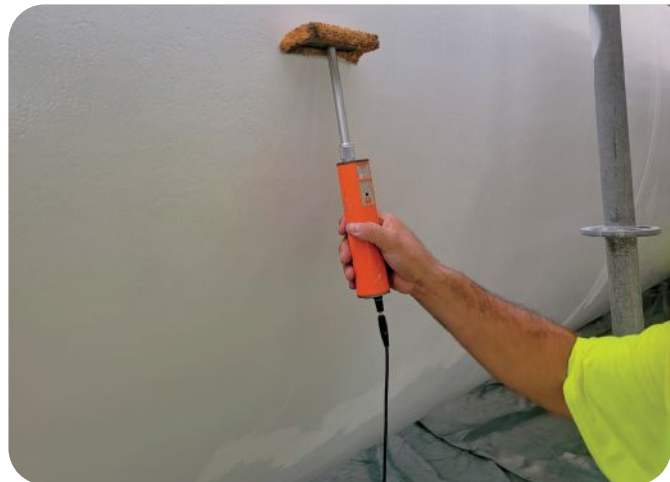
temperature. Working in September meant working during one of the hottest months of the year. Ambient temperatures reached up to 102 °F (39 °C).

According to Heuslein, vapor blasting creates a kind of slurry when the water and media mix together, but it was so hot on the jobsite that they didn’t even need to use the dust collector that they’d rented from MES Equipment for that specific material. They didn’t even get a chance to turn it on! “It was so hot that [the slurry] just dried and then we just swept it up,” he said.

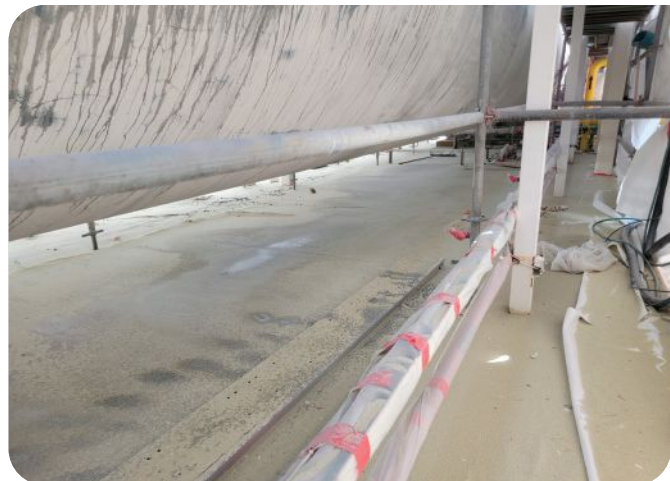
First, the crew power washed the exterior to remove grease, dirt, and debris using 4,000 psi. Dried material on the ground was removed and disposed of, as was the glass media since so little was used.

It was time for the crew to get to work. With the scaffolding and 9-mil (228.6 microns) poly containment up, they power washed the exterior first to remove any grease, dirt, or debris. That was completed using a Mi-T-M 4,000 psi (27.6 MPa) power washer. The dried materials on the ground were removed and disposed of at a local waste site.

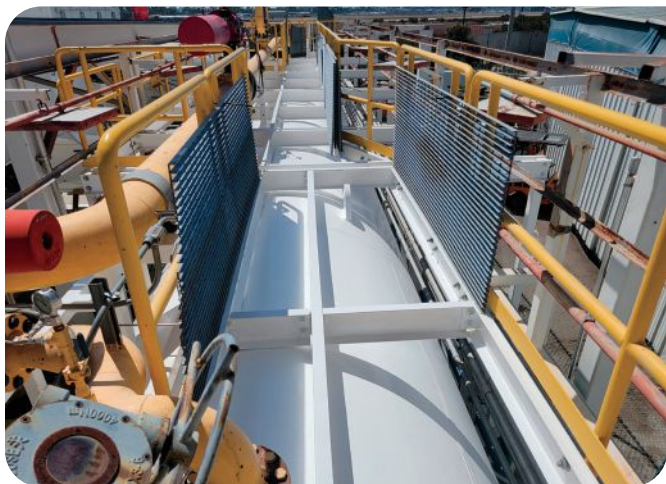
Working in September in San Diego meant dealing with ambient temperatures up to 102 °F. That required that the crew follow an IIPP to avoid heat exhaustion.

The heat also required that the crew follow an Injury and Illness Prevention Program (IIPP) for Southern California, which, in this case, meant taking frequent breaks and changing the person on the blasting nozzle so they can get water. These precautions were taken in order to avoid heat exhaustion.

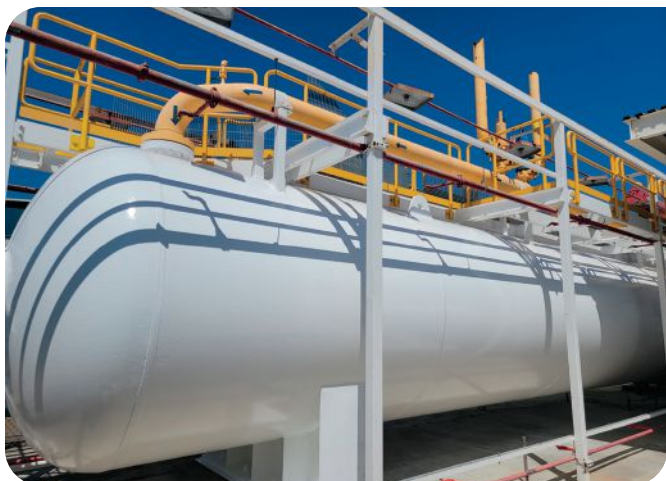
"I just got another compliment the other day on how beautiful it looks," Heuslein said. "It looks like it was dipped. Looks brand new."

The crew got the job done in three weeks, and it came out looking great. "I just got another compliment the other day on how beautiful it looks," Heuslein said. "It looks like it was dipped. Looks brand new." That's a sunny outcome for all. **CP**
